Increasing Adoption of Irrigation and Water Recycling Technologies in Australian Nurseries

FINAL Report for Project PA 57134

Research Conducted by David Hunt, Scientist DPI&F Queensland,
Funding support from Australian Government National Landcare
Program and Nursery & Garden Industry Australia

Increasing Adoption of Innovative Irrigation Technologies in Australian Nurseries

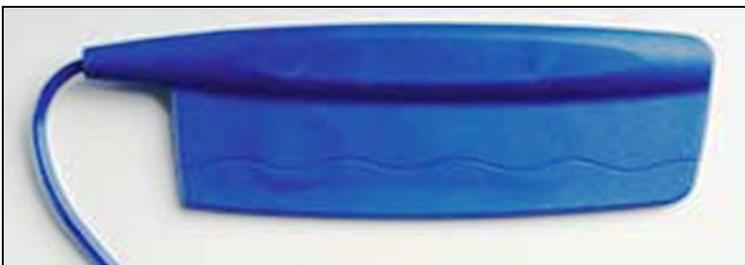
The AquaSpy SMS is a wired capacitance sensor sealed within a durable plastic shell. It measures 163 mm long (sensor length), 72 mm wide at the widest point and is 20 mm thick at the spine tapering down to 5 mm at the edge of the sensor paddle. It comes hard wired with a cable 5 metres in length that can be extended with a proprietary extension cable. Several sensors can be daisy-chained to provide a single run of cable of up to 1000 metres. The AquaSpy sensor can be connected to a data node for continuous data logging or an AquaBlu solenoid controller for direct solenoid control (Agrilink website 2007).

Figure 1: Agrilink AquaSpy soil moisture sensor

The software provided with the data node allows for the output to be represented in graphical form showing daily, weekly, fortnightly and monthly trends, or can be converted into MS Excel for further analysis. The SMS has a built-in temperature sensor that monitors the sensor temperature, which the control software uses to adjust for the effects of hysteresis and also provides the nursery manager with a way of monitoring container temperatures.

There are two primary issues that limit the installation of this device into an existing, older timed irrigation controller. Firstly, the output signal used is a digital signal (RS 485) and is not commonly recognised by irrigation controllers used in many containerised nurseries today. An upgrade of older irrigation controllers would be needed if actual soil moisture values were required. Secondly, a computer is required to program the sensors and display the data in graphical form.

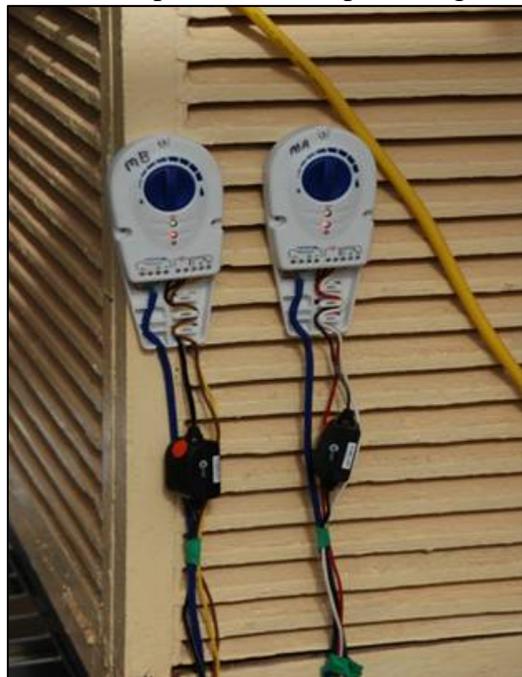
Agrilink have developed an independent interface that will negate the use of a computer, the AquaBlu solenoid controller. These solenoid interfaces, with a built-in percentage control knob, is designed to link the soil moisture sensor directly to an irrigation solenoid or to an irrigation controller through a digital (on/off) rain switch input. The AquaBlu does not interact with the irrigation controller or require a change to the original irrigation programming when connected directly to the irrigation solenoid but will turn off the irrigation solenoid once the soil moisture has reached the preset level or percentage. The irrigation manager can adjust the percentage at the

Figure 2: Agrilink AquaBlu regulator

growing bed, but unfortunately this method will only control one solenoid and a separate AquaBlu and sensor would be required for each irrigation zone/solenoid. When the AquaBlu is connected to an irrigation controller via a digital rain switch, the sensor can effectively control several solenoids at once, but again does not provide any actual soil moisture values.

Although the AquaBlu would be an appropriate option for growers that wish to control 1 or 2 growing beds separately from the main controller it will not provide any data for monitoring purposes or provide actual container moisture figures. The nursery manager would be required to physically assess container moisture in a traditional manner to determine set points (the percentage knob position) until the optimum positions are found.

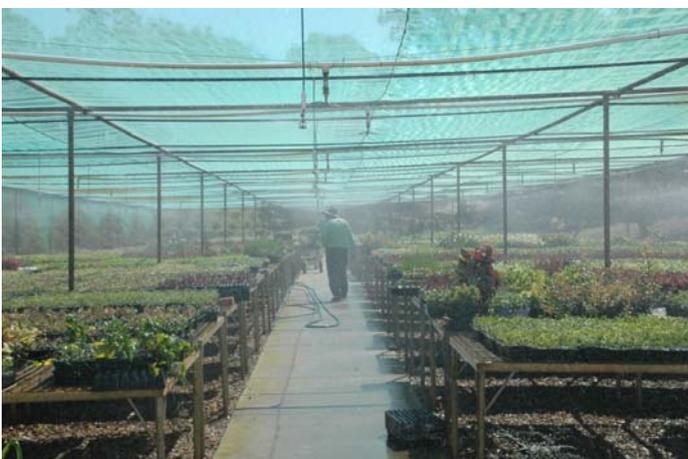
Even in protected structures such as a shadehouse, wind can influence the application efficiency of the sprinklers, as discovered with Shadehouse 3 at Nursery 2. This shadehouse is the propagation

transitional or hardening-off area for the nursery and the irrigation system was designed to provide an appropriate application rate of 8.6 mm/hr to suit. However, the small droplet size was affected by wind blowing through the shadehouse, disrupting the application uniformity and reducing the MAR to half of what was expected. The nursery manager noted that there was insufficient application and had to increase the irrigation duration to provide enough water to sustain the plants. To correct this issue, the jets were replaced to provide a

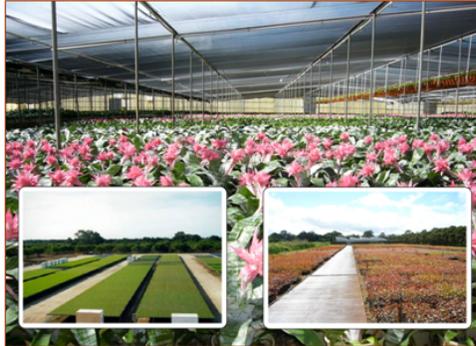
Nursery Production Economic Model

Income
Capital
Fixed Costs
Vairable Costs
DCF
DCF Summary
Overall Summary

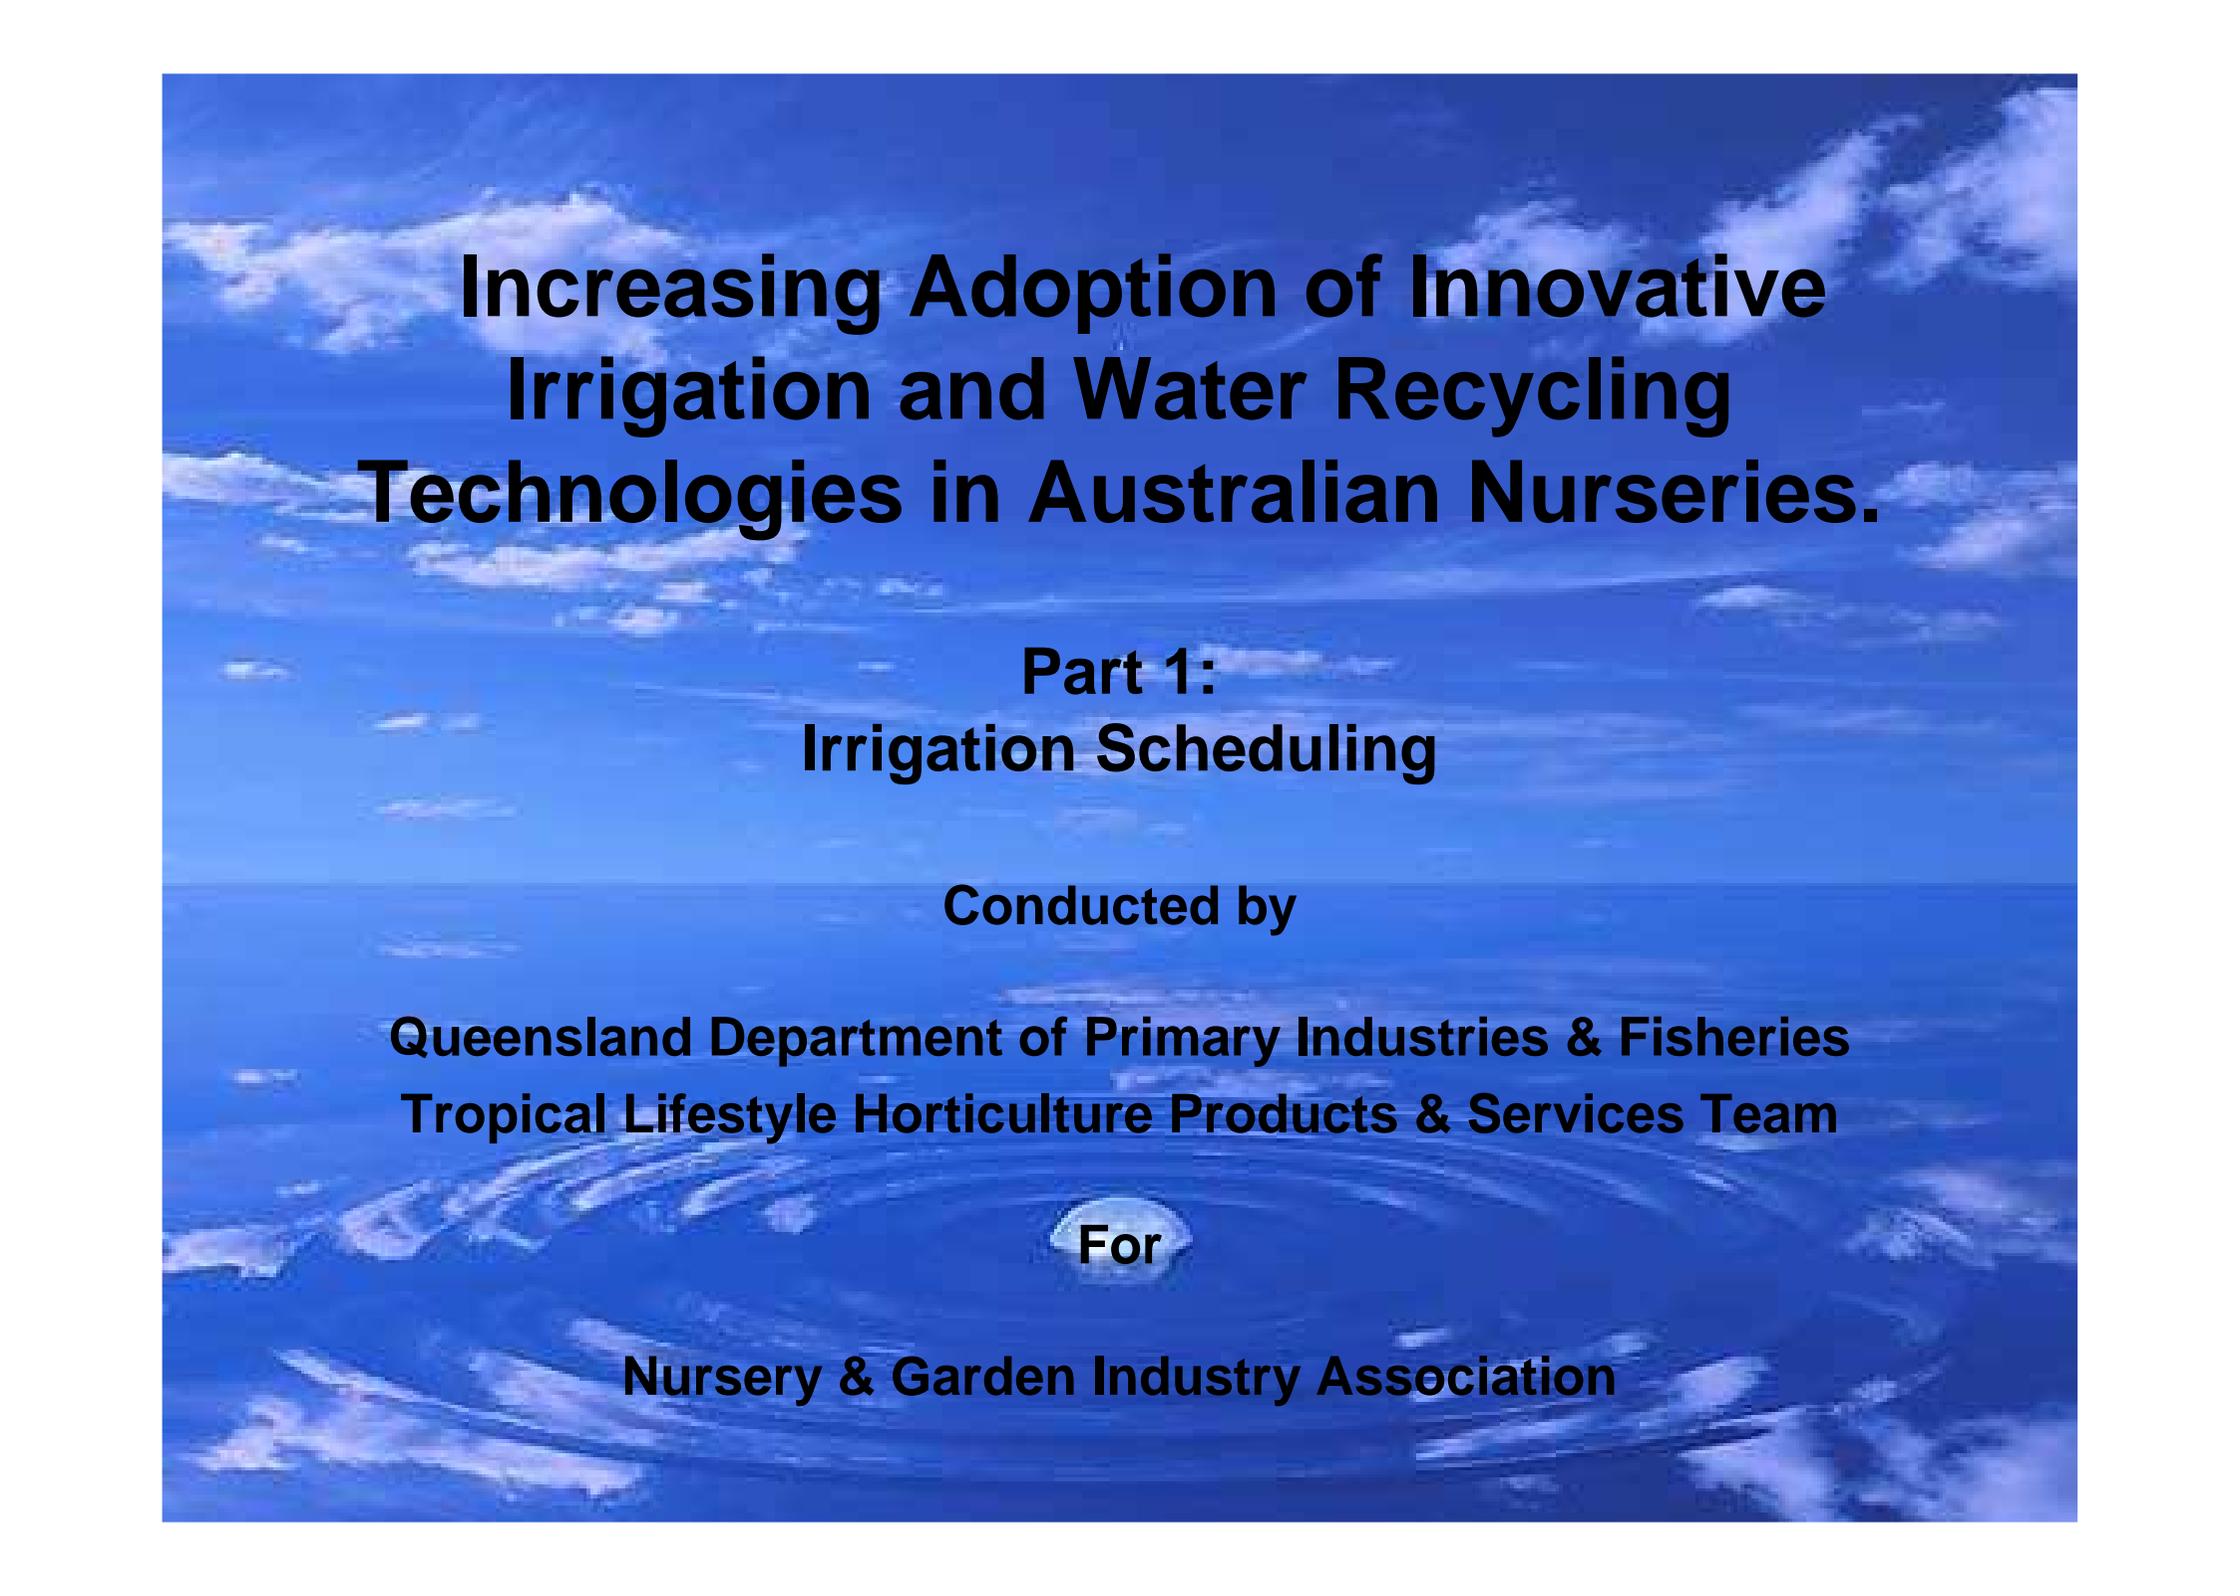
CURRENT SYSTEM		NEW SYSTEM	
Assets		Assets	
Land Area (Ha)	35	Land Area (Ha)	35
Value (\$/Ha)	\$75,000	Value (\$/Ha)	\$75,000
Production Area (Ha)	7.54	Production Area (Ha)	7.54
Land Value	\$2,625,000	Land Value	\$2,625,000
Plant & Equipment	\$2,435,000	Plant & Equipment	\$2,510,000
TOTAL ASSETS	\$5,060,000	TOTAL ASSETS	\$5,135,000
Total Income	\$3,701,938	Total Income	\$3,711,938
Number of Staff (FTE's)	20.0	Number of Staff (FTE's)	19.0
Expenses		Expenses	
Variable Costs	\$493,120	Variable Costs	\$492,938
Fixed Costs	\$182,521	Fixed Costs	\$156,375
Depreciation	\$182,214	Depreciation	\$189,814
Total Expenses	\$857,855	Total Expenses	\$839,127
Net Profit	\$2,844,083	Net Profit	\$2,872,811
BENCHMARKS		BENCHMARKS	
Return on Investment	56.2%	Return on Investment	55.9%
Income per Hectare	\$490,973	Income per Hectare	\$492,300
Income per Square Metre	\$49.10	Income per Square Metre	\$49.23
Income per FTE	\$185,097	Income per FTE	\$195,365

Annual Water Usage (ML)	29.2	Annual Water Usage (ML)	17.5
WATER SAVING (ML)		WATER SAVING (ML)	
	11.7		40%

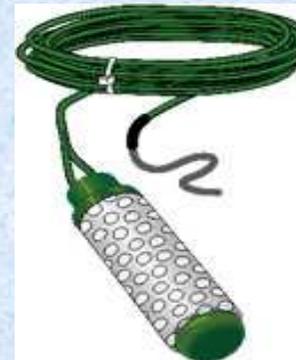
2) In-situ units (monitoring or automation tool)

- Technical experience needed to install
- Can be connected to irrigation controller
- More expensive

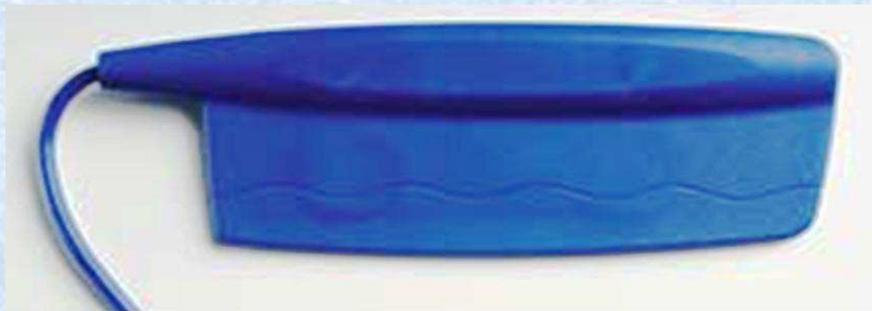
The AquaSpy soil moisture sensor and Ech2o soil moisture sensor .

Both are a capacitance sensor, 200mm in length and measure the volumetric moisture content of soil.

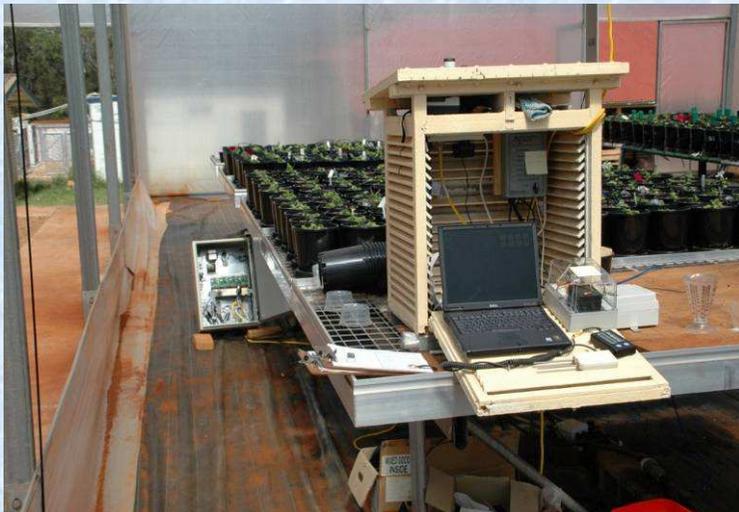
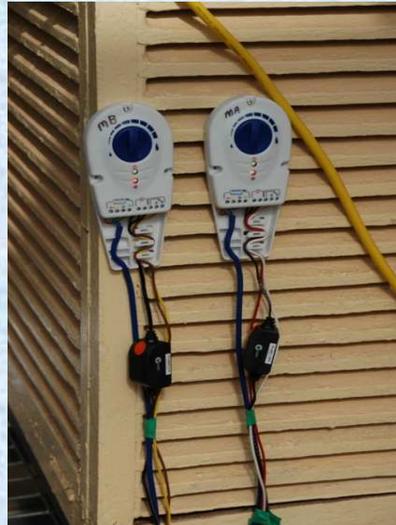
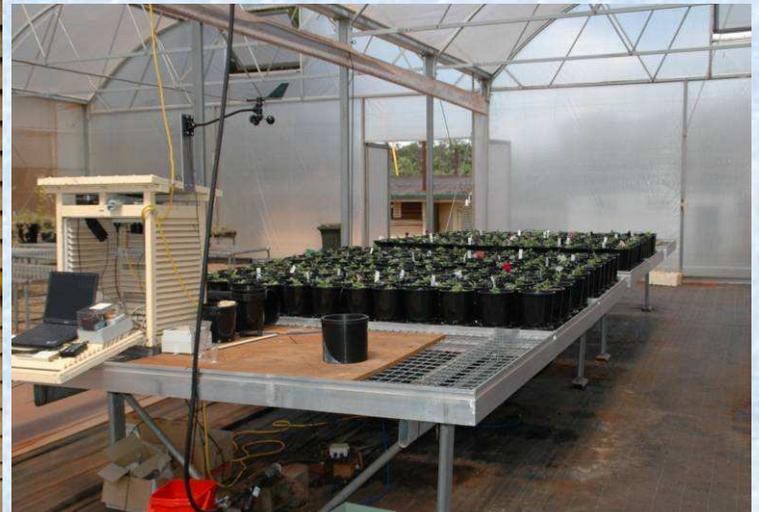
Irrigation Scheduling Trial

- Conducted in a poly-tunnel at Redlands Research Station
 - 4 Treatments – Timed, Deficit & 2 soil moisture sensors controlled scheduling
 - * Ech2o sensor connected directly to Teven Logic encoder irrigation controller
 - * AquaSpy sensor connected via a regulator to a rain input on irrigation controller
 - A drip irrigation system used to match infiltration rate of media
 - 2 media types used – A = Pine bark (85%), Sand (15%);
B = Pine Bark (85%), Coir (15%)
 - Petunia *Var.* in 200 mm containers
- Trial run for 4 months with 1 month of automation
- * Only operator input was entering the previous 24 hr ET value for deficit irrigation
 - * Adjustment of AquaSpy regulator to suit climatic conditions

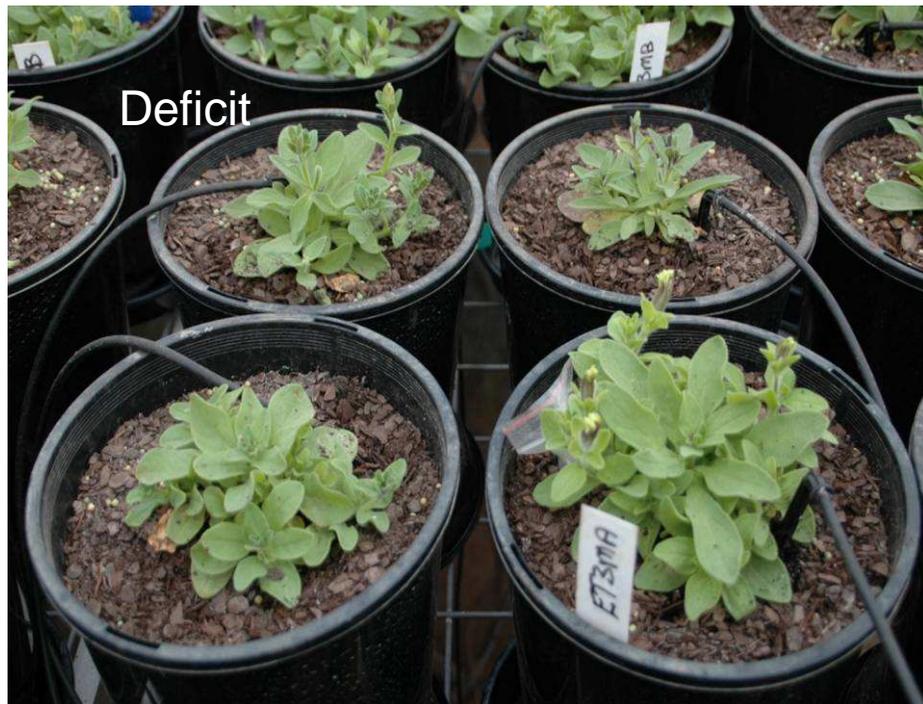
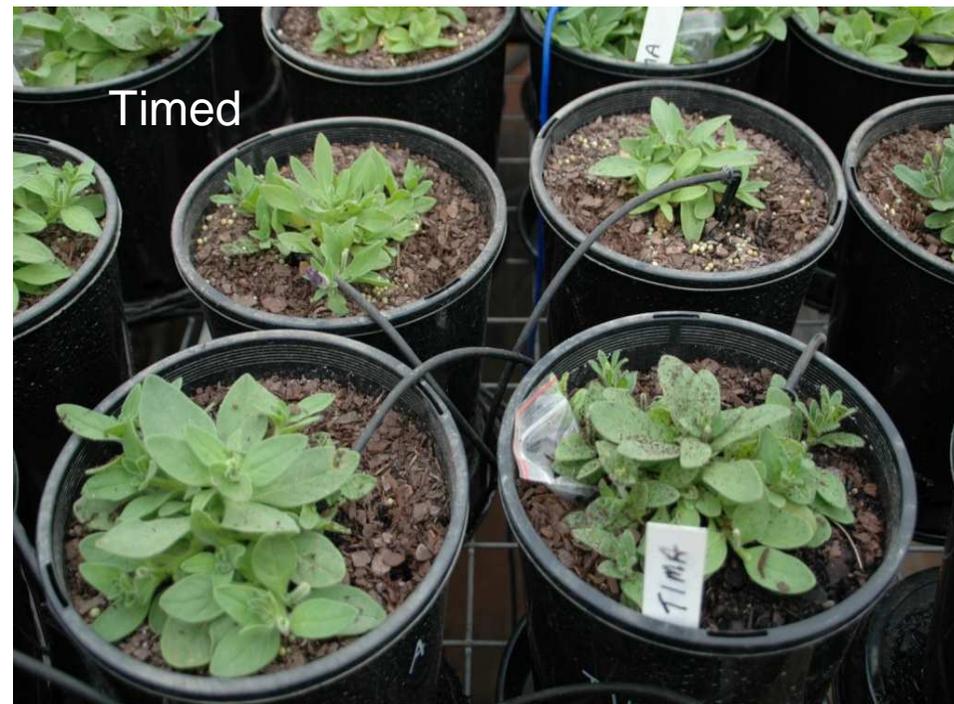
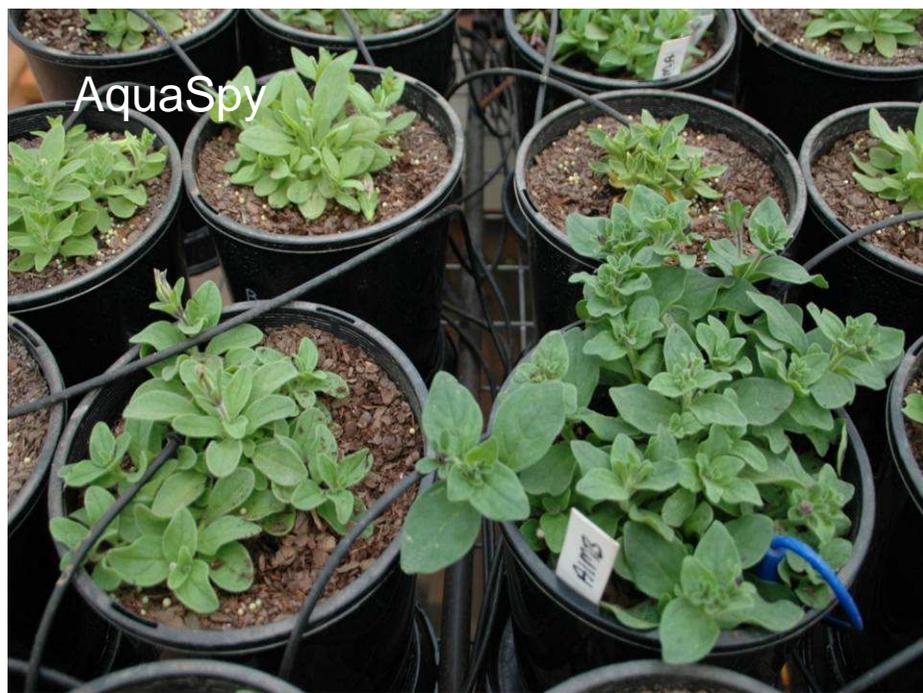
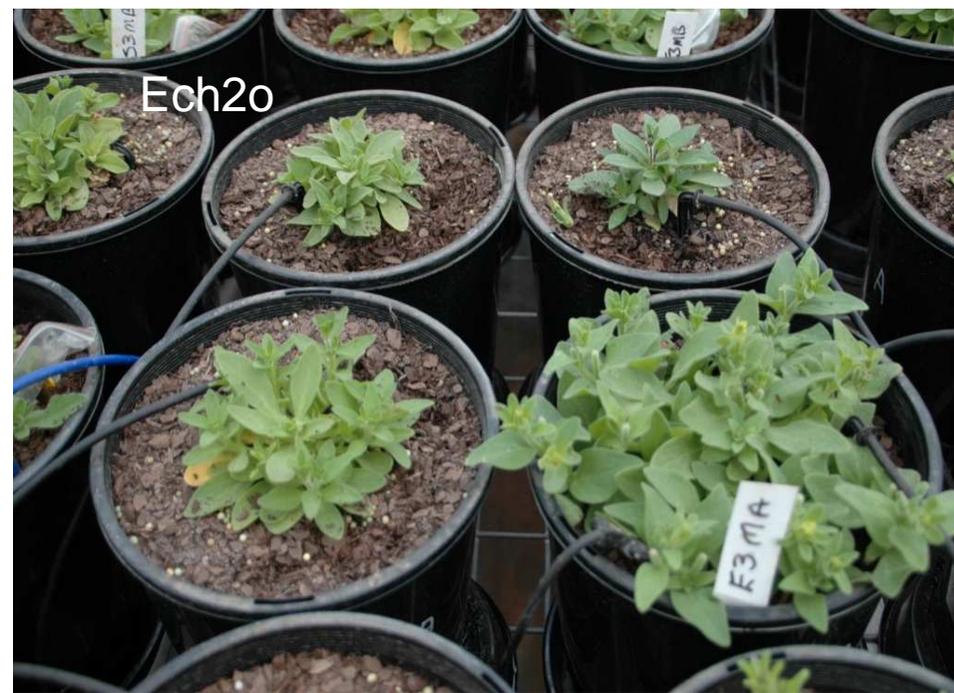
- At the end of the trial, there was no significant difference in plant growth or quality between the irrigation types.
- However, there was minor significant differences in plant growth within the first several weeks after planting.
- Timed irrigation scheduling showed a lower growth rate than all other scheduling methods in the first 2 months after planting.
- Media B (pine bark (85%), Coir (15%)) showed a higher ranking in the first 2 months.

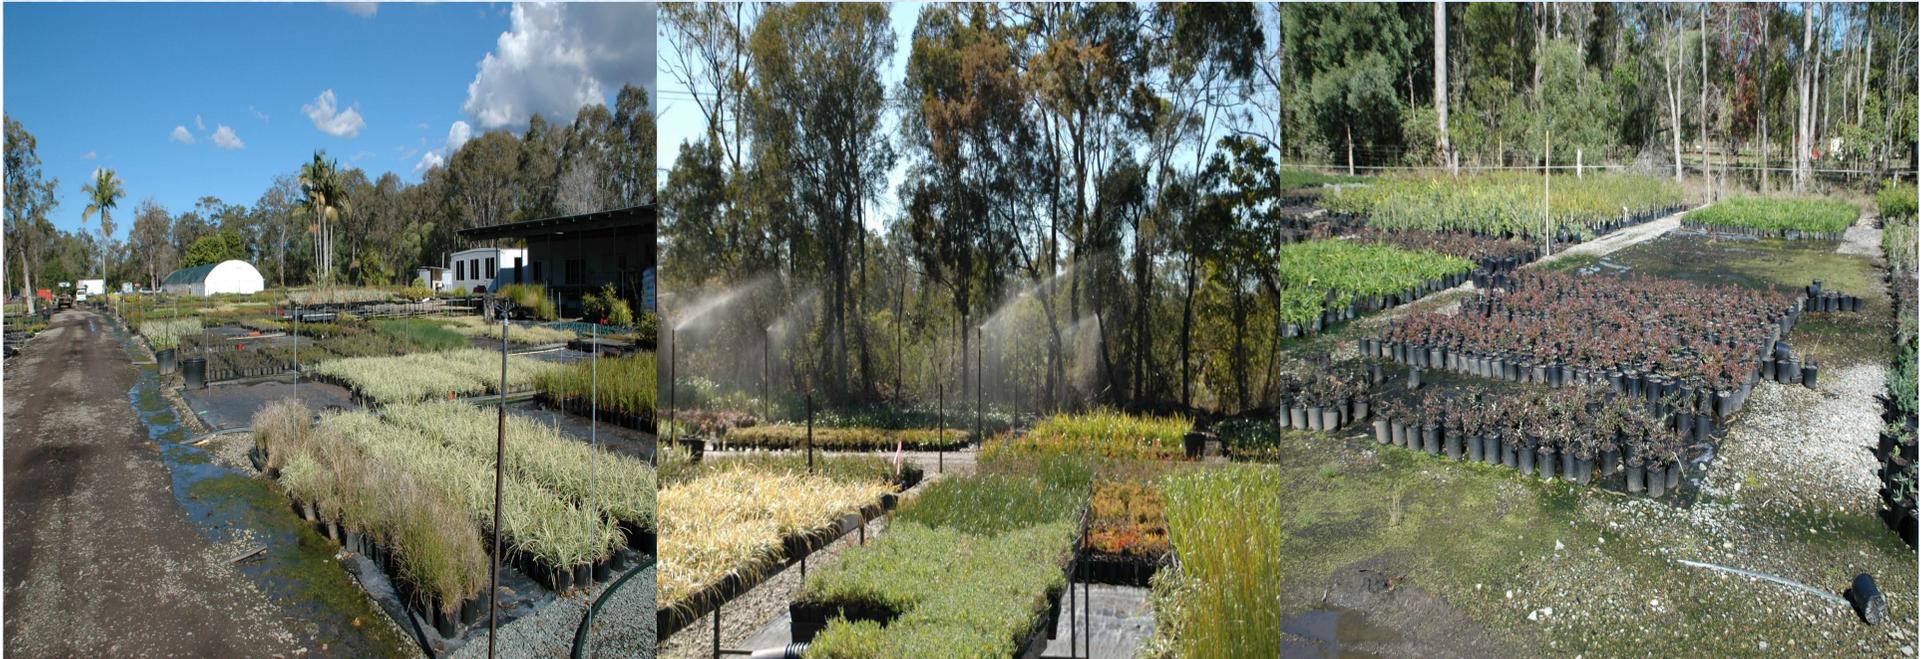
Old MAR = 8.8mm/hr New MAR = 9.1mm/hr	Old MAR = 7.9mm/hr New MAR = 12.9mm/hr	Old MAR = 11.4mm/hr New MAR = 8.6mm/hr	Old MAR = 6.1mm/hr New MAR = 9.7mm/hr	Old MAR = 11.5mm/hr New MAR = 5.1mm/hr	Old MAR = 13.1mm/hr New MAR = 8.7mm/hr
Old CU = 69.6% New CU = 92.2%	Old CU = 60.4% New CU = 91.6%	Old CU = 68.7% New CU = 92.2%	Old CU = 70.5 New CU = 94.4%	Old CU = 54.4% New CU = 86.5%	Old CU = 66.4% New CU = 91.6%
Old SC = 1.98 New SC = 1.41	Old SC = 5 New SC = 1.36	Old SC = 2.26 New SC = 1.21	Old SC = 3.23 New SC = 1.13	Old SC = 3.63 New SC = 1.35	Old SC = 3.45 New SC = 1.26

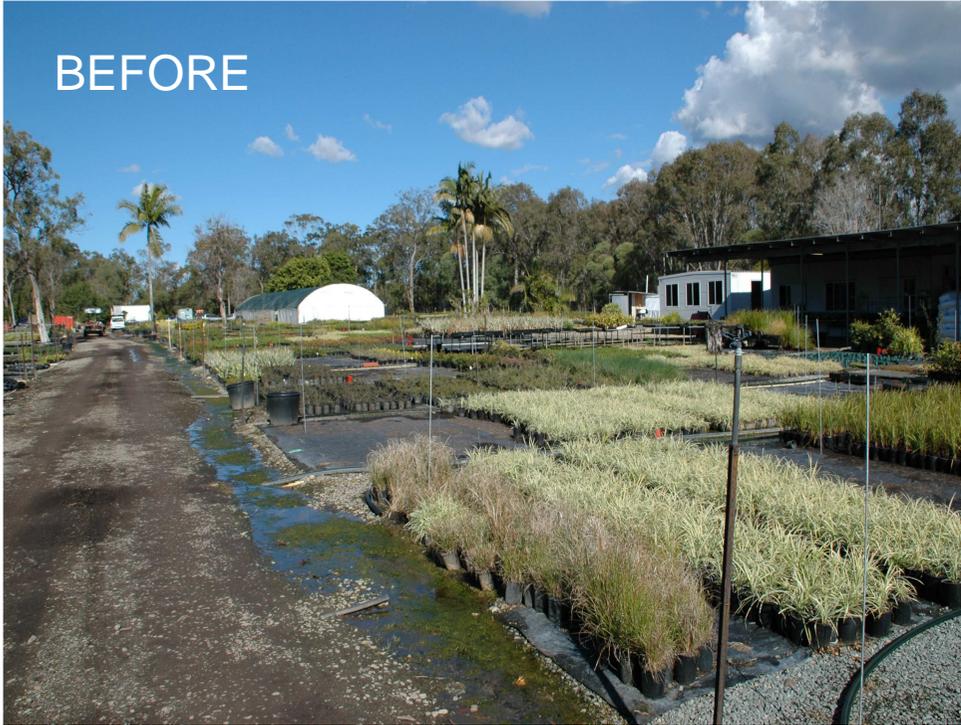
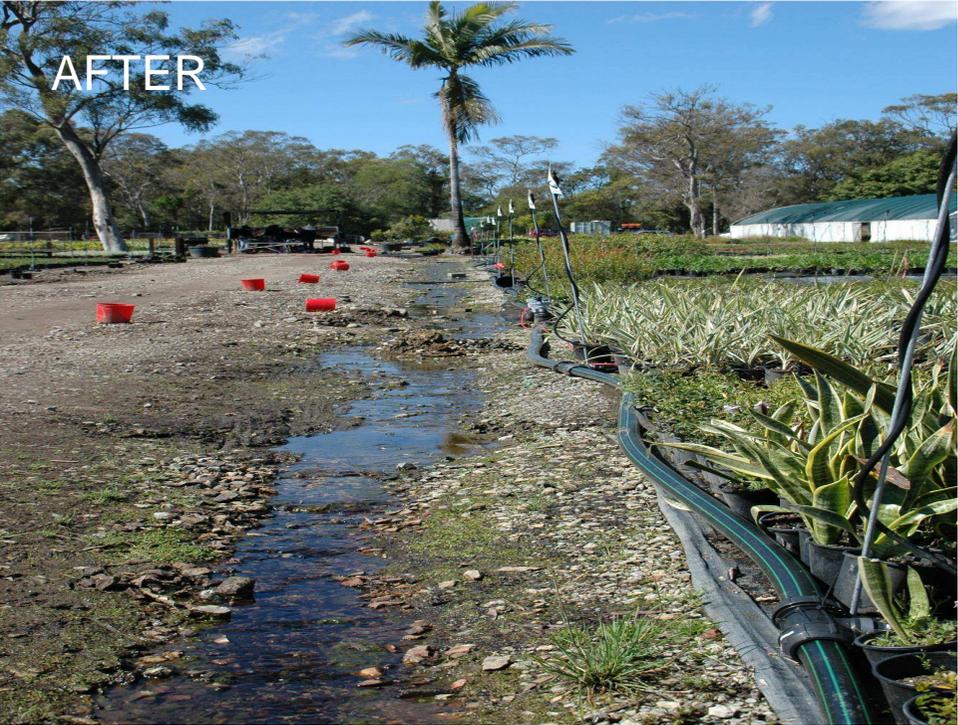
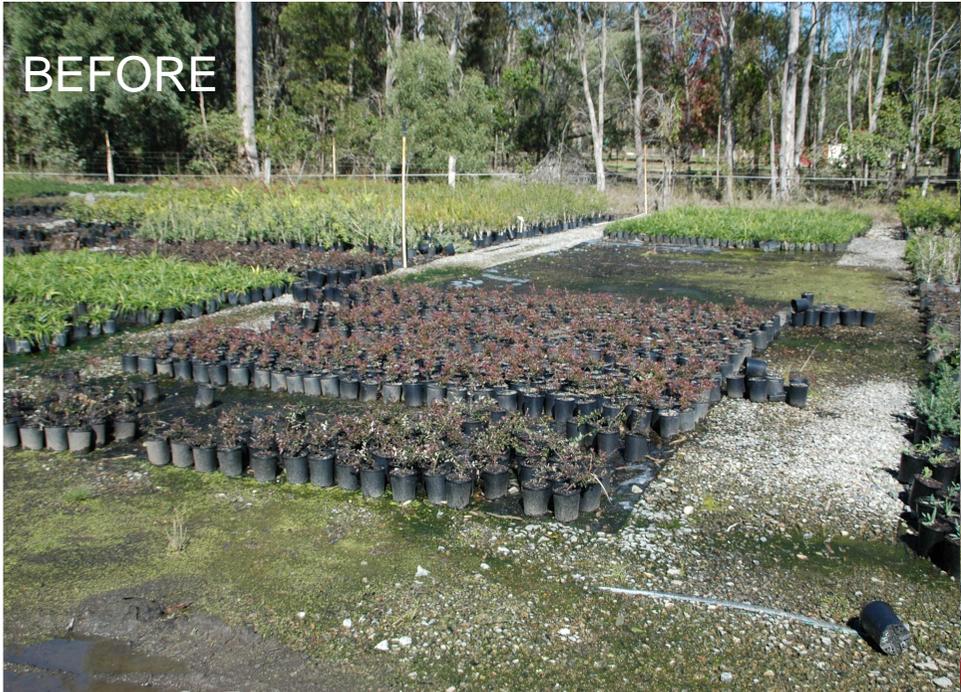
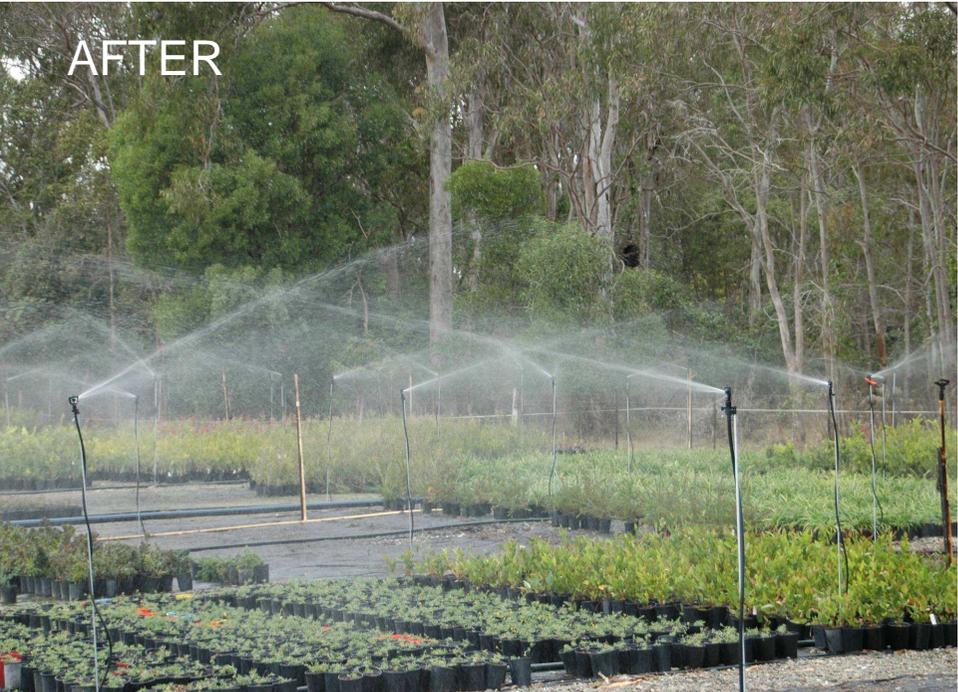
- Replaced irrigation system from sand filters
- new mainline & disinfestation coil
- Outside bed laterals at 5m x 5m

- Shadehouse laterals to suit production type,
- New sprinklers - jets to suit production type,
- Adjusted scheduling to suit new system

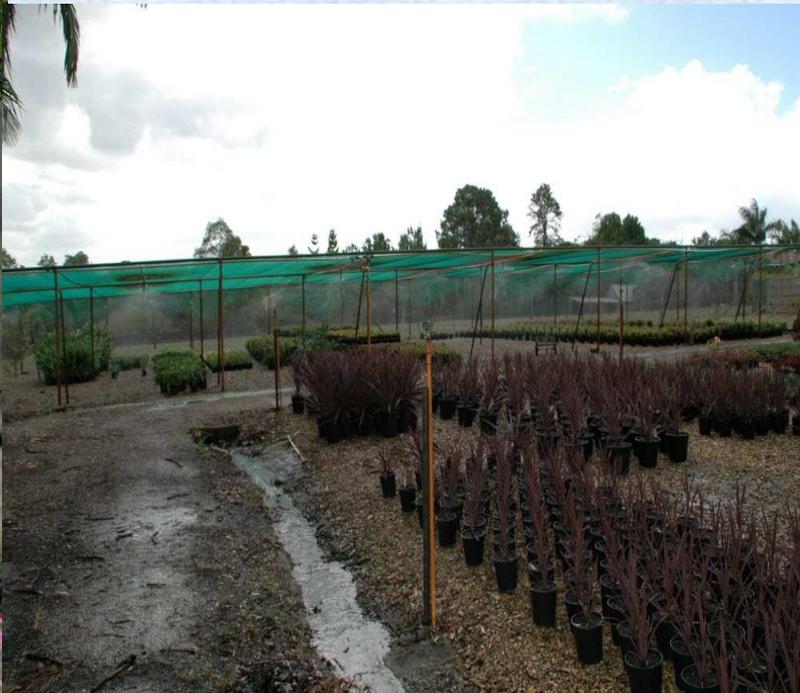
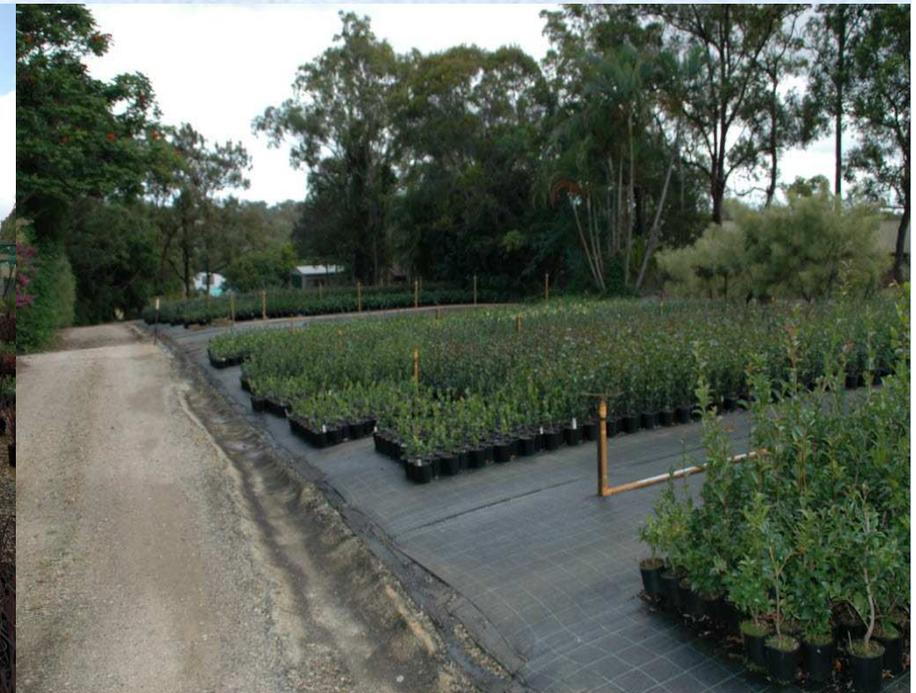
Nursery 2

<p>Old MAR = 27.9 mm/hr New MAR = 10.6 mm/hr</p> <p>Old CU = 69% New CU = 88.7%</p> <p>Old SC = 3.15 New SC = 1.2</p>	<p>Old MAR = 29.2 mm/hr New MAR = 10.6 mm/hr</p> <p>Old CU = 74.5% New CU = 88.2%</p> <p>Old SC = 2.10 New SC = 1.4</p>	<p>Old MAR = 16.6 mm/hr New MAR = 8.4 mm/hr</p> <p>Old CU = 85.7% New CU = 86.5%</p> <p>Old SC = 1.75 New SC = 1.33</p>	<p>Old MAR = 16.7 mm/hr New MAR = 17.3 mm/hr</p> <p>Old CU = 61.5% New CU = 97.3%</p> <p>Old SC = 2.91 New SC = 1.03</p>	<p>Old MAR = 13.6 mm/hr New MAR = 8.4 mm/hr</p> <p>Old CU = 66.4% New CU = 86.5%</p> <p>Old SC = 3.09 New SC = 1.33</p>
---	---	---	--	---

Old Irrigation System 100% Dam Water Supply

- 15 to 20 year old irrigation system installed as nursery grew over generations
- Sprinkler spacings and riser heights relatively consistent – similar sprinkler types
- Irrigation uniformity average but **mean application rates excessively high**
- Used 24.5 ML per year
- Growing beds well maintained and clean
- Excellent runoff collection drains running back to onsite dam
- Chlorine dosing system in installed
- Minimal occurrence of disease

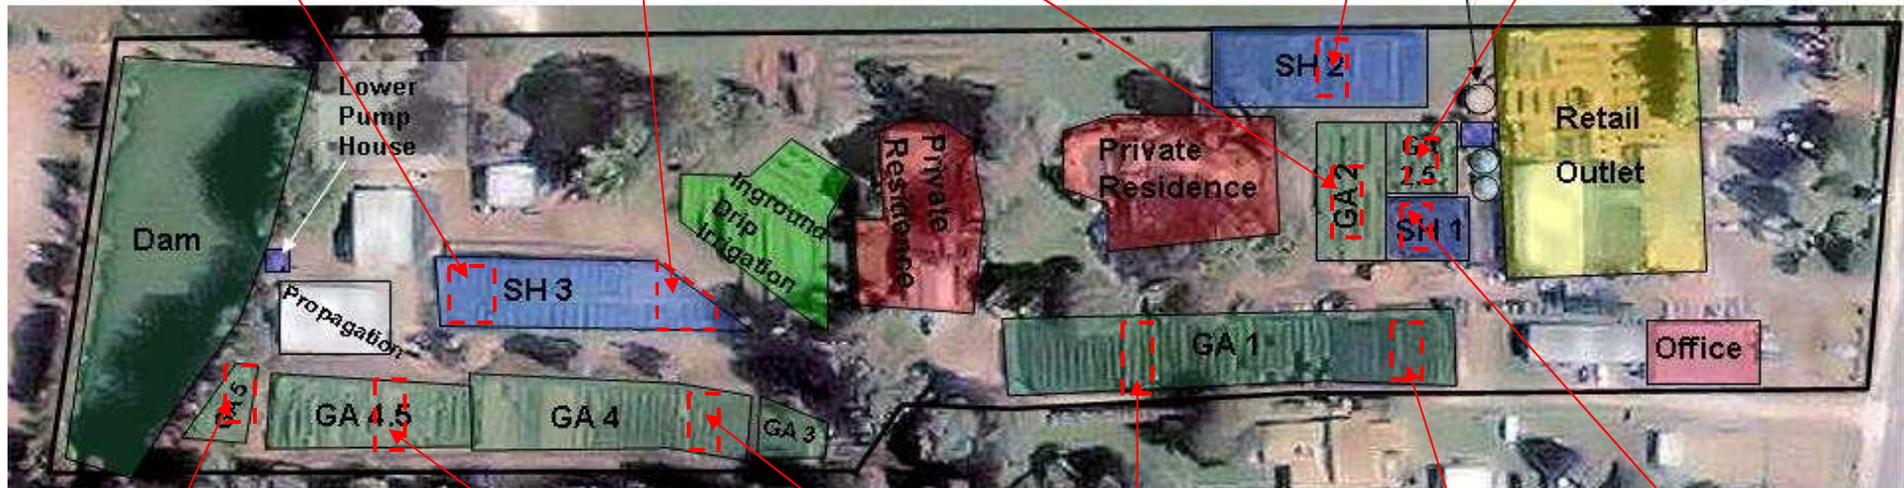
<p>Old MAR = 32.5 mm/hr New MAR = 10.6 mm/hr</p> <p>Old CU = 82.6% New CU = 92.5%</p> <p>Old SC = 1.84 New SC = 1.16</p>	<p>Old MAR = 21 mm/hr New MAR = 10.2 mm/hr</p> <p>Old CU = 85.6% New CU = 92.8%</p> <p>Old SC = 2.08 New SC = 1.25</p>	<p>Old MAR = 29.2 mm/hr New MAR = 12.2 mm/hr</p> <p>Old CU = 88% New CU = 92.8%</p> <p>Old SC = 1.65 New SC = 1.25</p>	<p>Old MAR = 39 mm/hr New MAR = 10.7 mm/hr</p> <p>Old CU = 90.7% New CU = 92.3%</p> <p>Old SC = 2.21 New SC = 1.23</p>	<p>Old MAR = 28.6 mm/hr New MAR = 9.9 mm/hr</p> <p>Old CU = 69.2% New CU = 90.2%</p> <p>Old SC = 2.51 New SC = 1.31</p>	<p>Old MAR = 50.6 mm/hr New MAR = 9.6 mm/hr</p> <p>Old CU = 61.1% New CU = 91.6%</p> <p>Old SC = 5.01 New SC = 1.27</p>
--	--	--	--	---	---

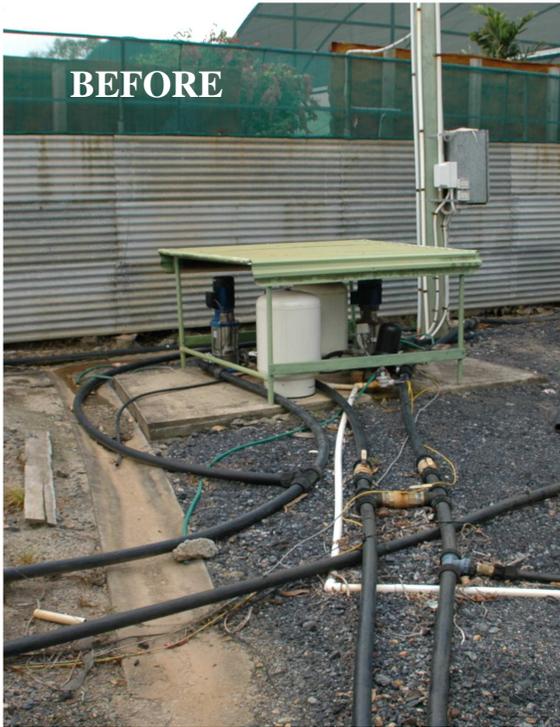
BEFORE

- Replaced lateral lines but use existing mainline
- Tailored laterals to suit irregular shaped bed & shadehouse
- New sprinklers with different jets to suit production type
- Installed a VFD pump controller – reduced line pressure
- Centralised irrigation controllers - 3 old to 1 new

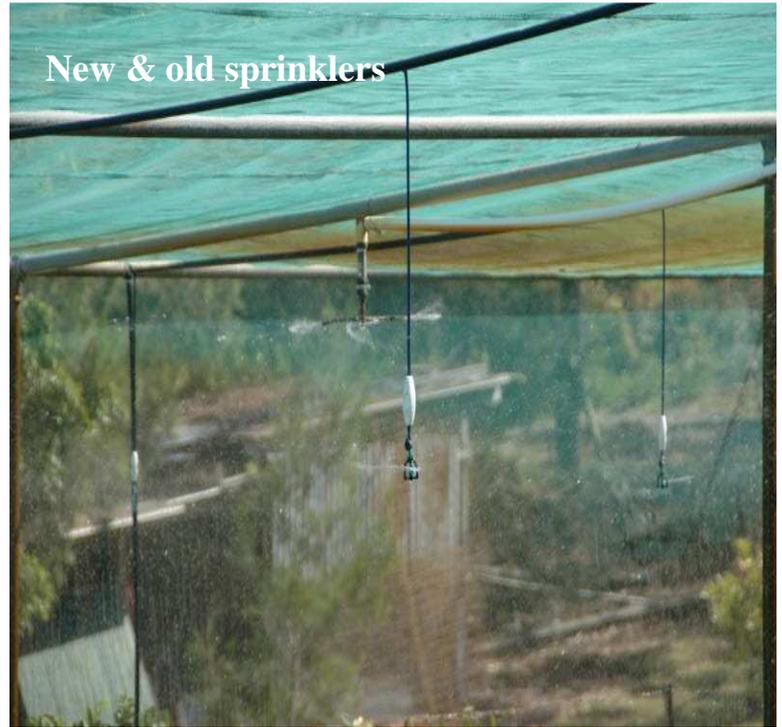
New & old sprinklers

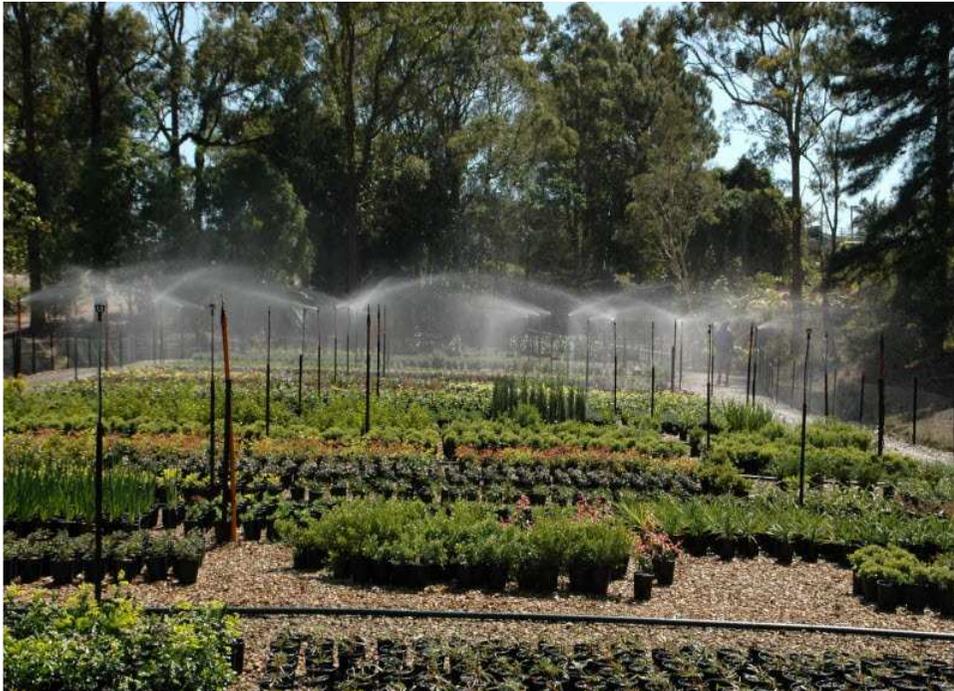
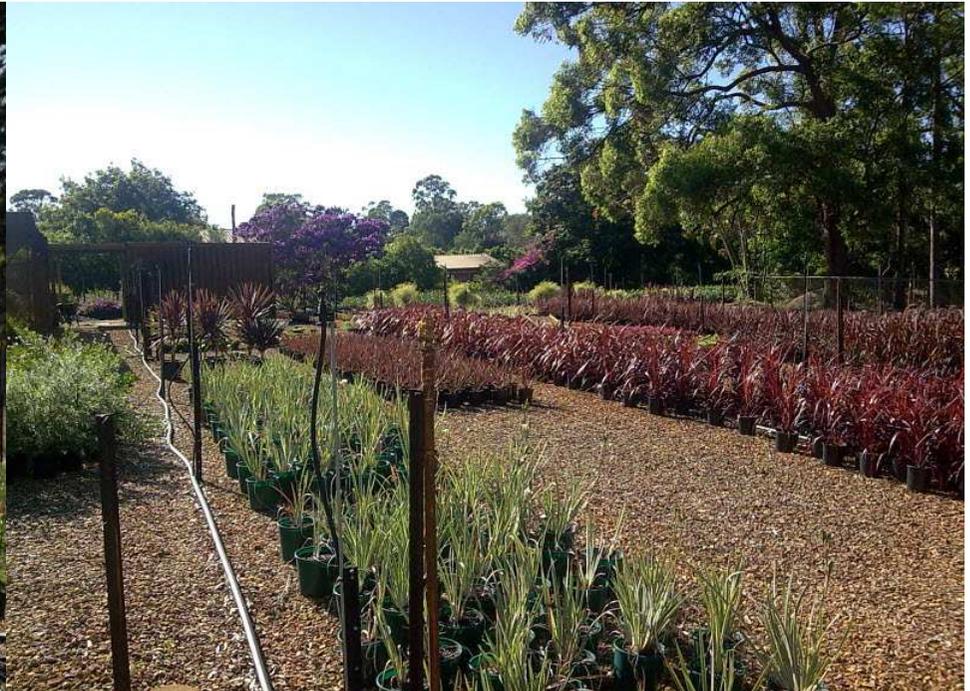
Nursery 1: Uses town and dam water

- Reduced total yearly water use by 40% to 44% (9 ML/ year)
- Reduced town water use from 70% to 13% (14 ML/year)
- Saved approximately \$19,000 on town water costs
- Reduced plant throw outs by approximately 5%
- Reduced wet areas throughout the nursery leading to
 - Reduced outbreaks of plant disease
 - Reduced herbicide and fungicide usage
 - Improved plant uniformity and quality
- Improved irrigation efficiencies
- Irrigation application rates match media infiltration rates
